Plymouth Bridge Replacement Public Information Meeting

VT Route 100A – Bridge #9 over Pinney Hollow Brook

VT100 Plymouth/Bridgewater Bridge Improvement Projects Public Information Meeting

VT Route 100 – Bridge 108, 112, and 116

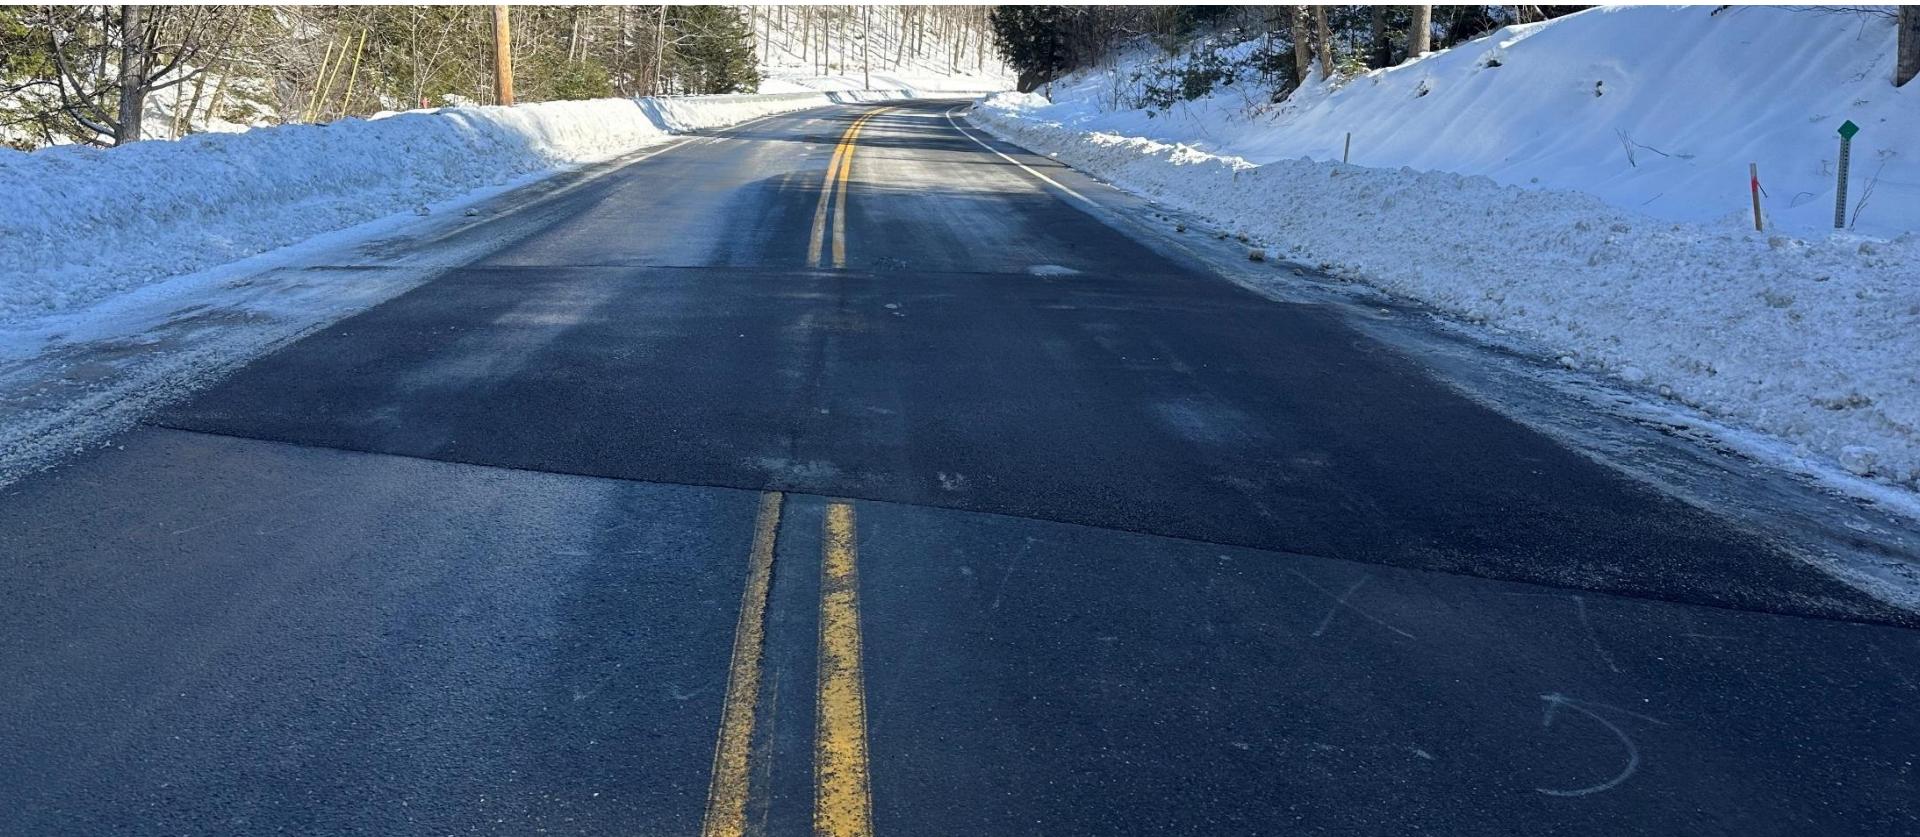
Existing Conditions *Looking East*

- Roadway Classification – Rural Major Collector
- Bridge Type – Single Span, Concrete Slab
- Structure Length – 31'
- Ownership – State Highway Agency
- Constructed in 1984

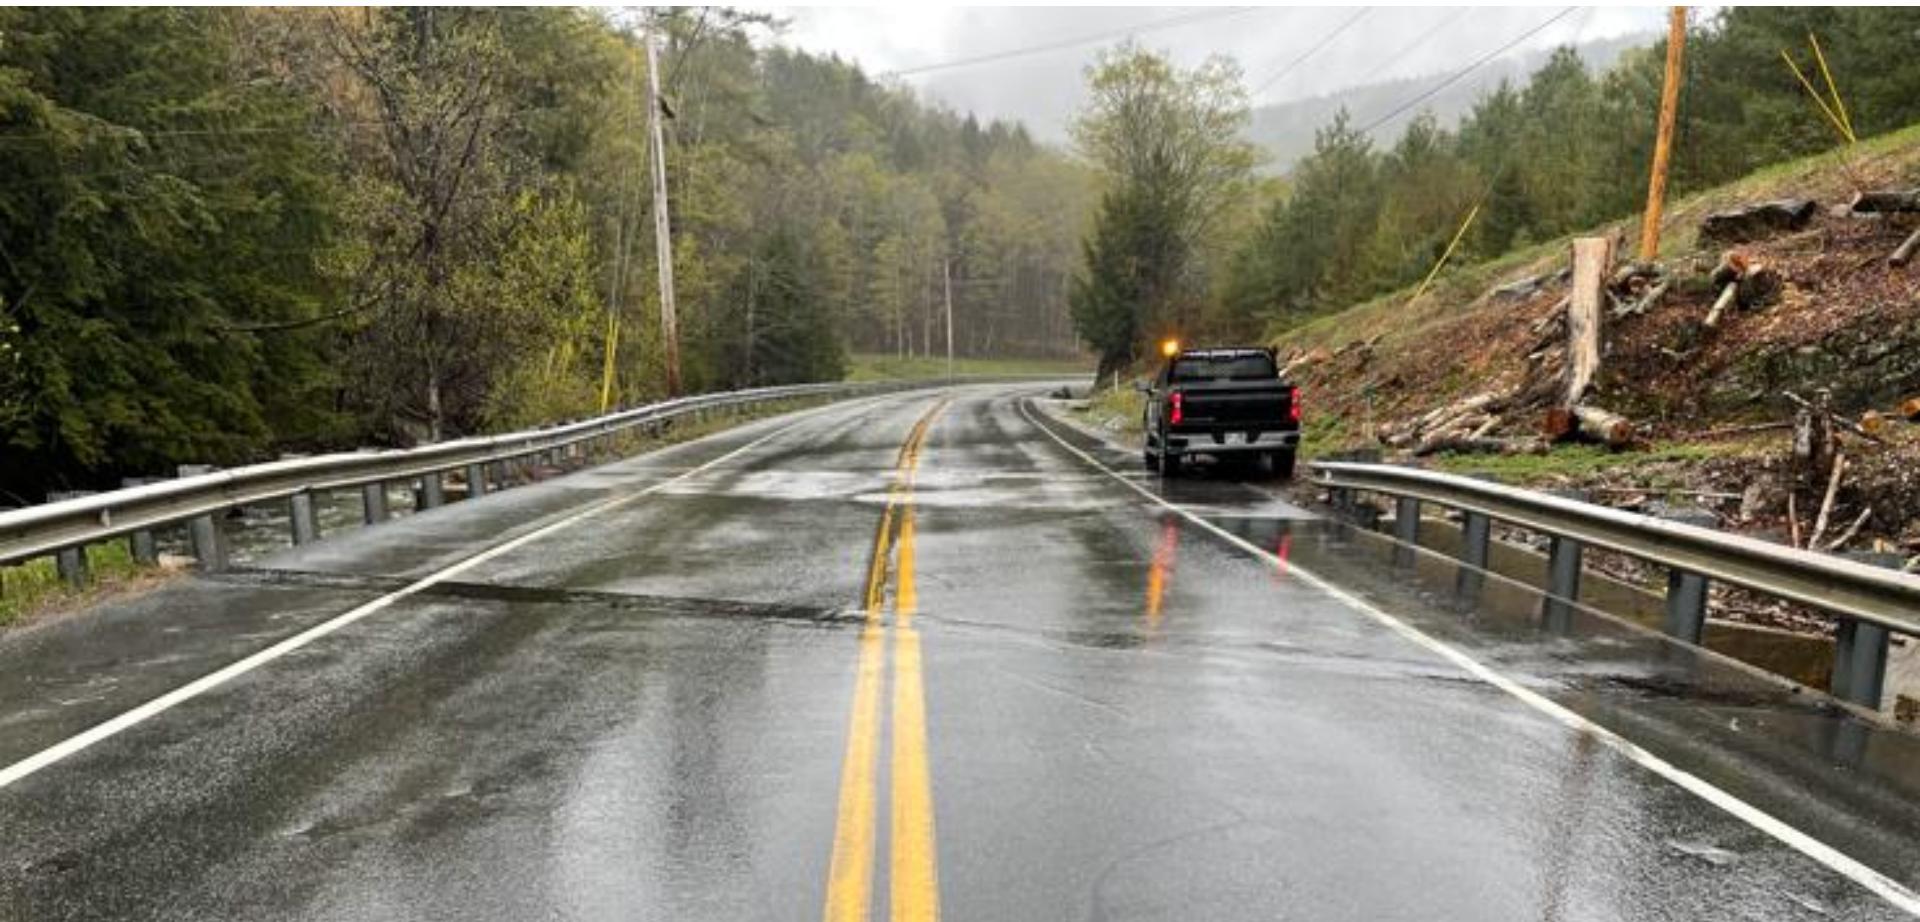
Existing Conditions *Looking East*

- Aerial Utilities

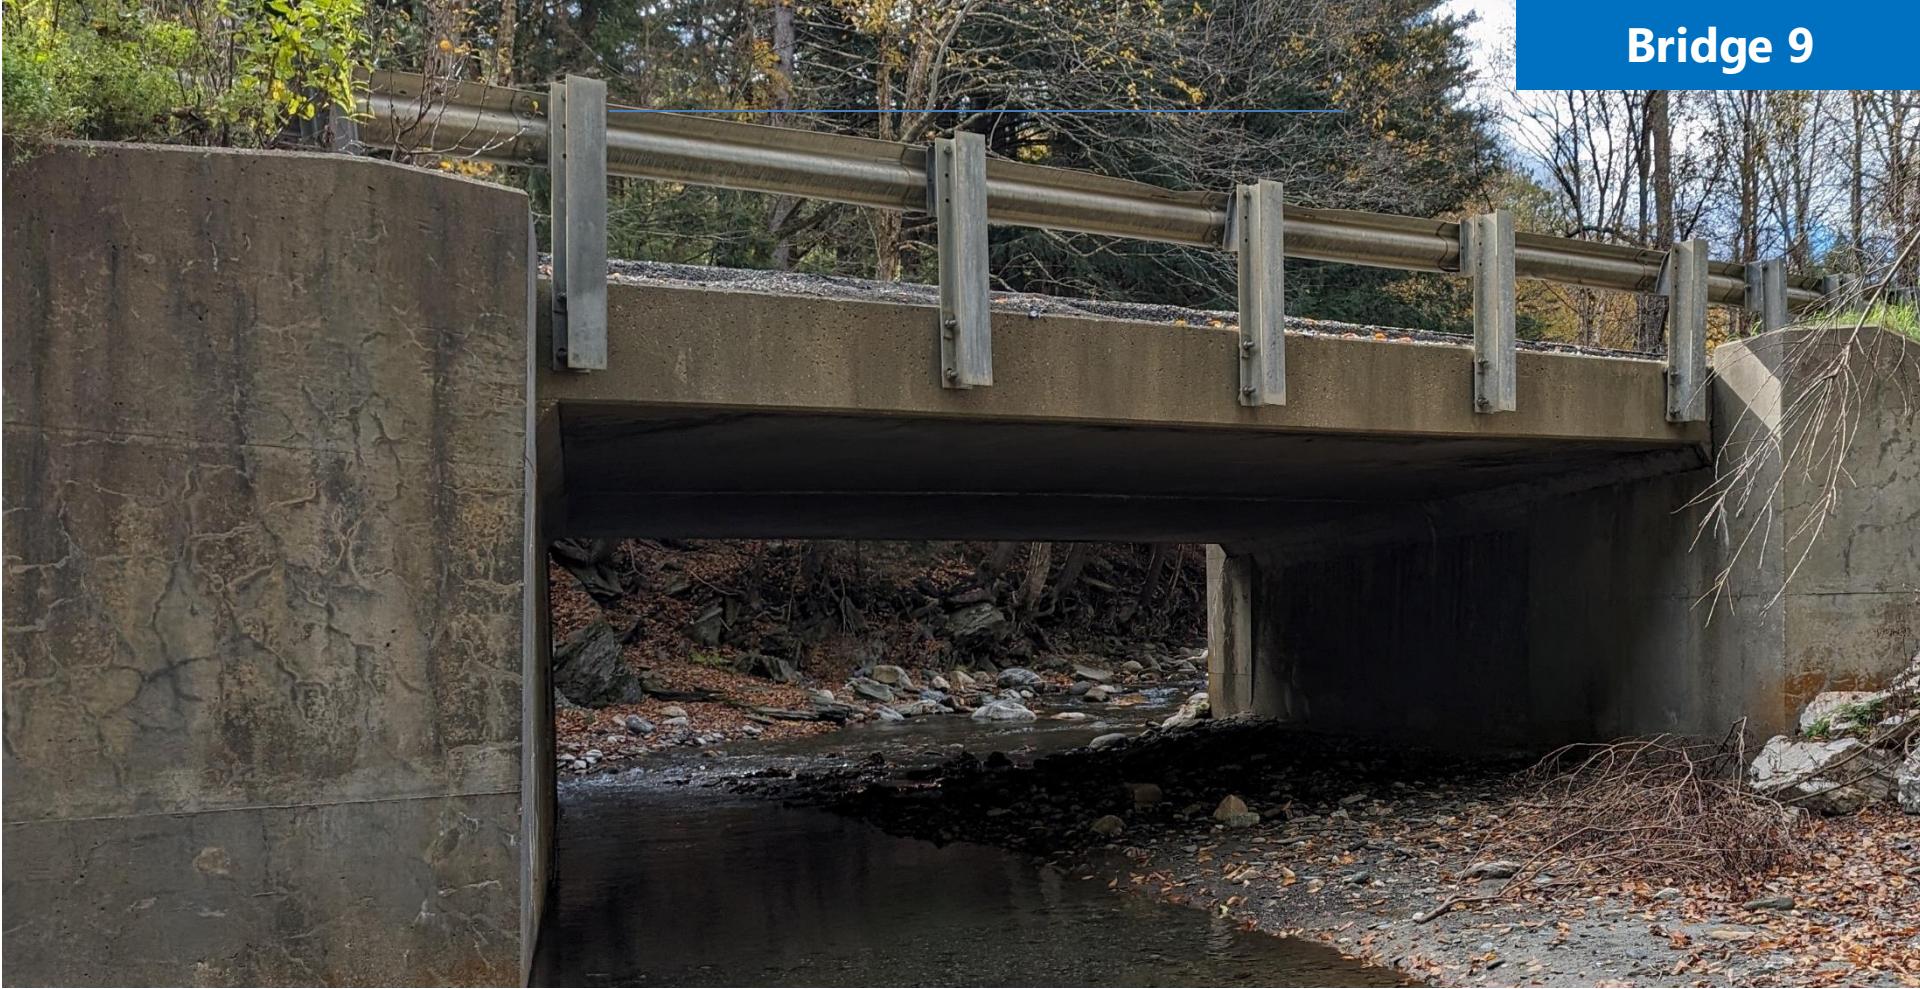
Existing Conditions *Condition Ratings*

- Deck Rating 7 (Good)
- Superstructure Rating 7 (Good)
- Substructure Rating 6 (Satisfactory)

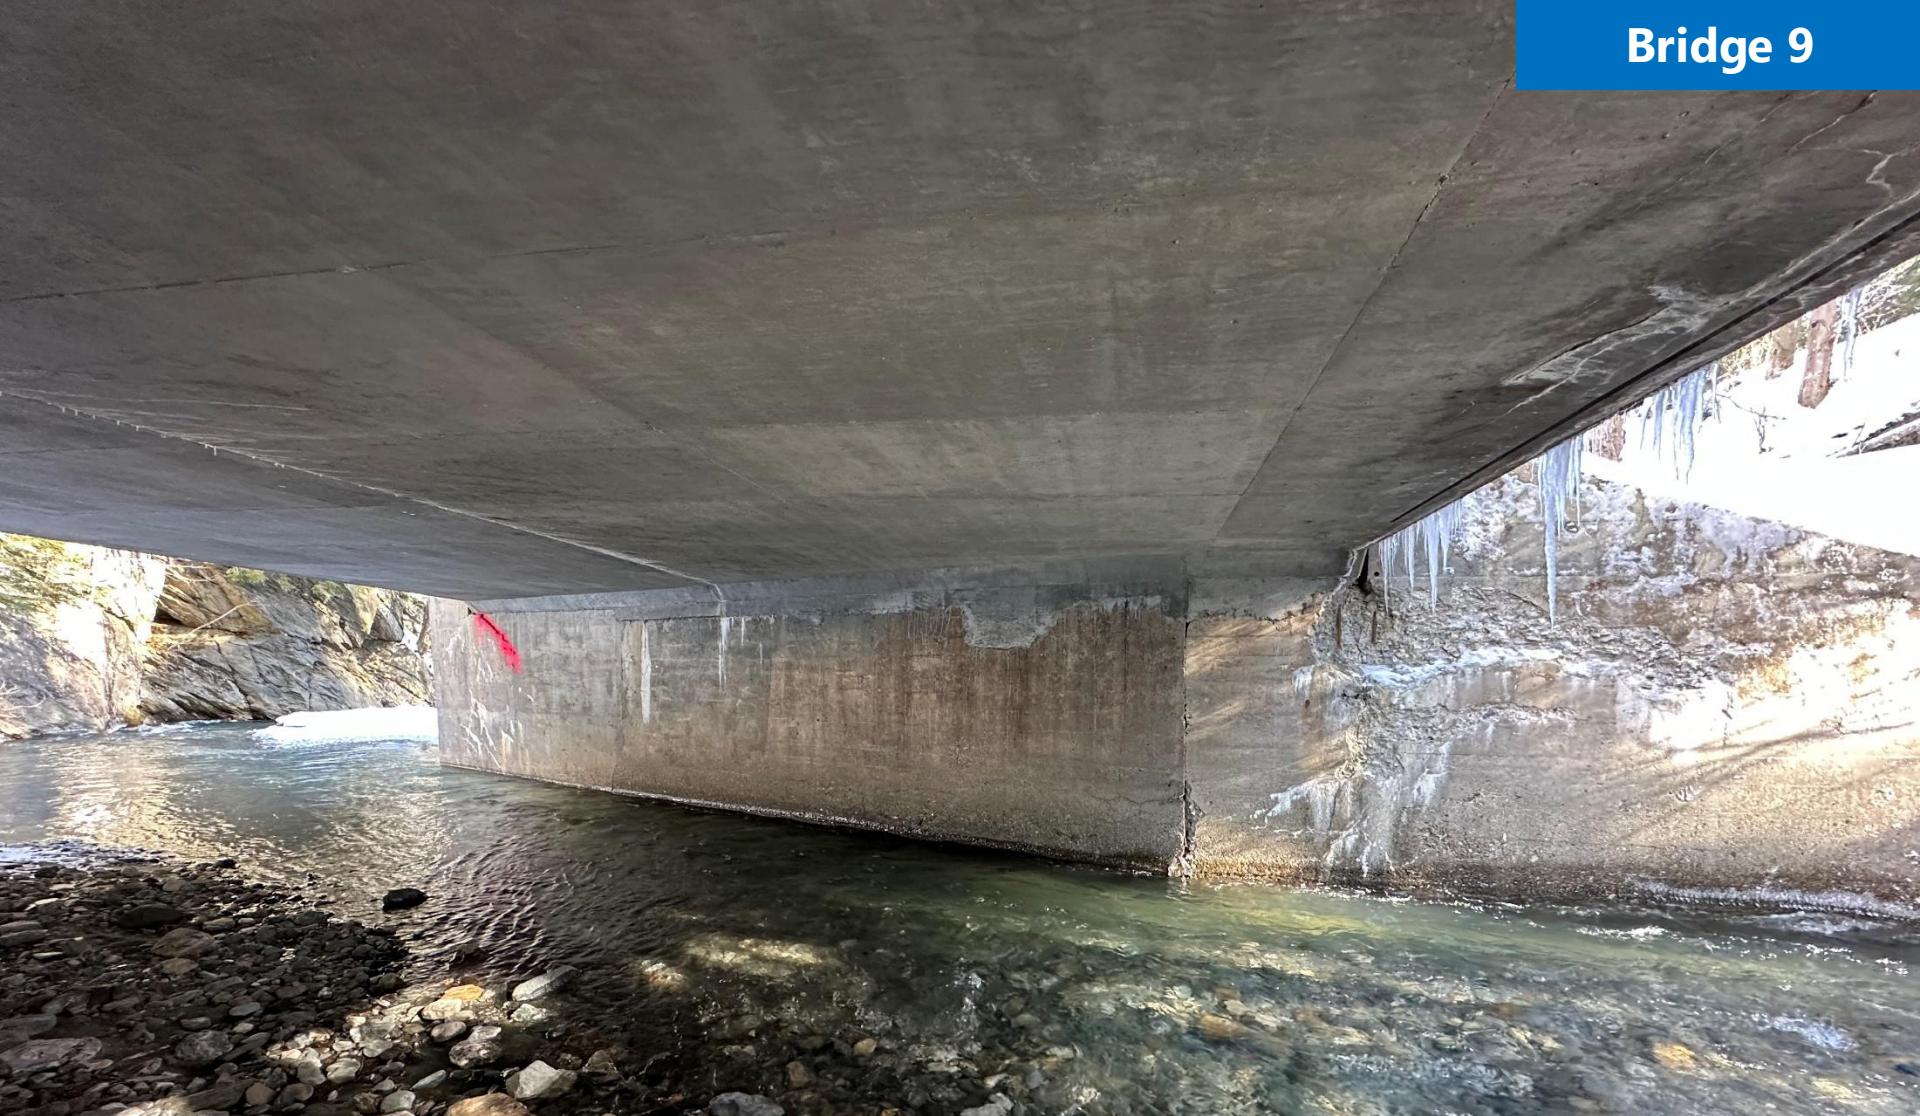
Existing Conditions *Underside of Deck*

- Cracking with leakage along center of bridge
- Upstream fascia has spalls with exposed rebar

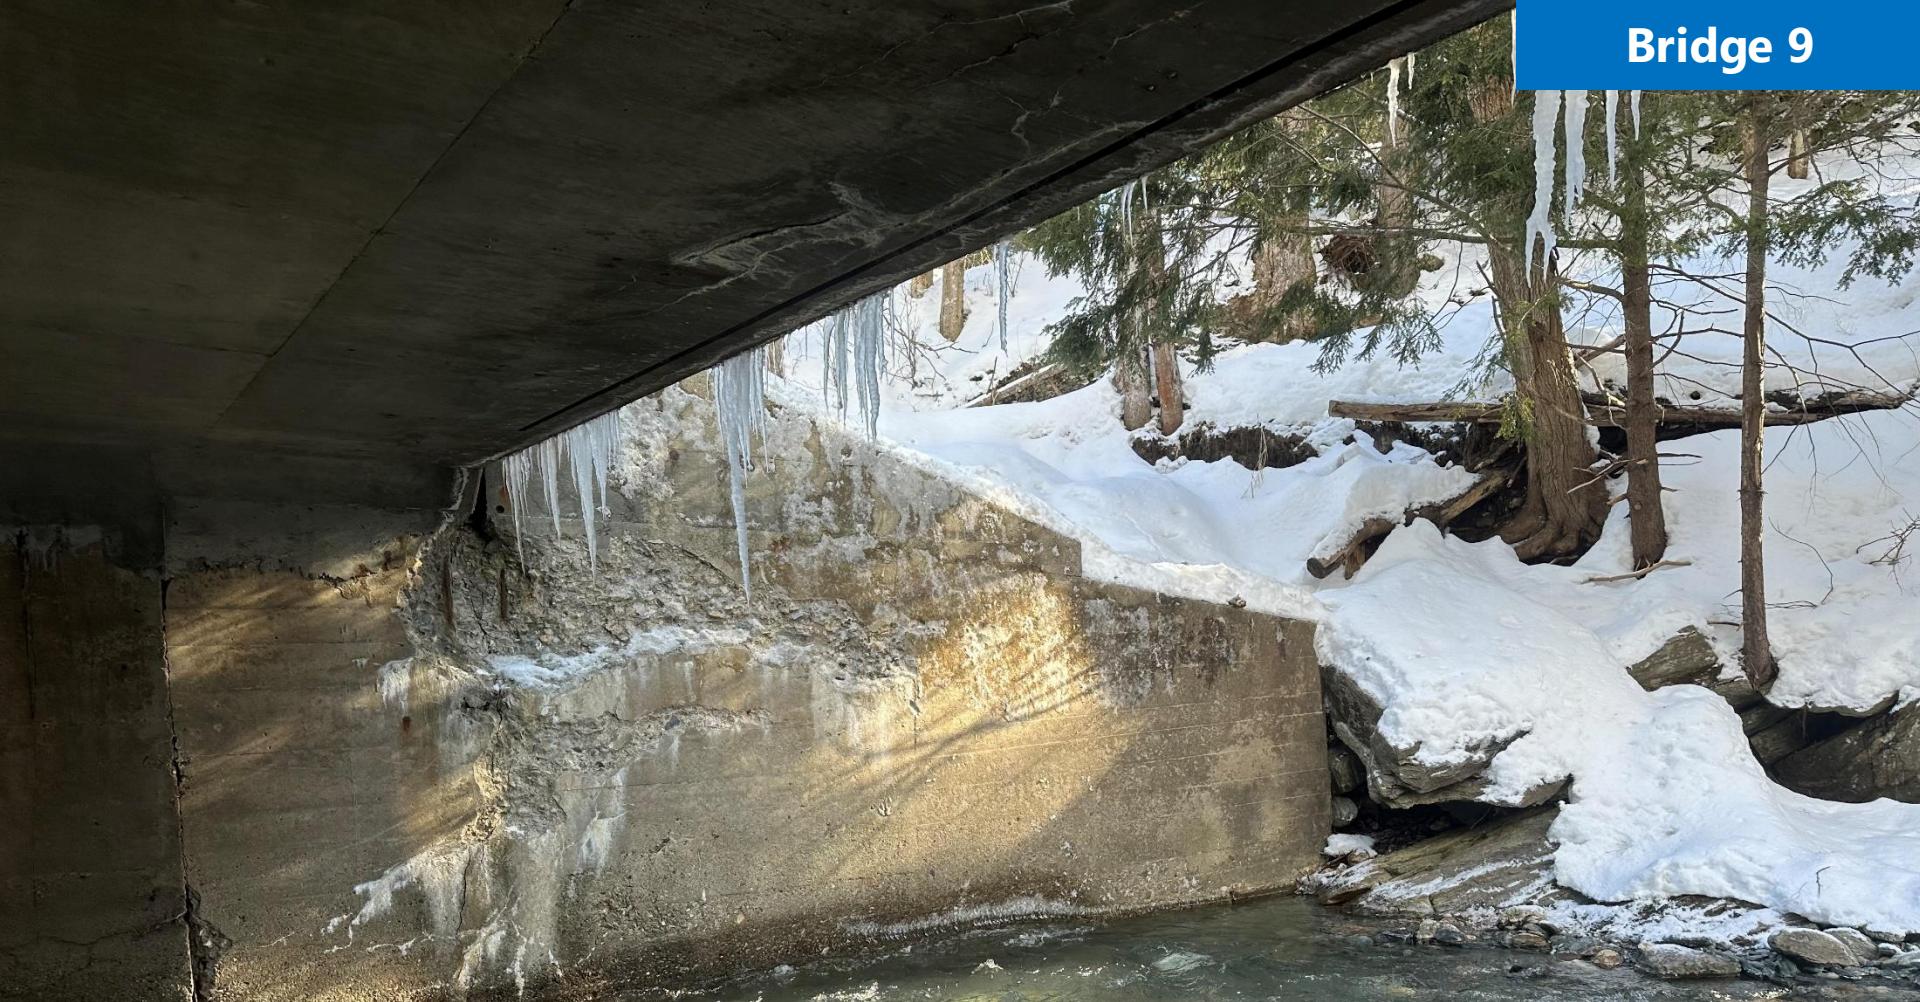
Existing Conditions *Abutment 2 Upstream Wingwall*

- Both abutments have areas of scaling
- Abutment 1 has cracking & saturation on ends
- Abutment 2 has spall with exposed rebar and areas of delamination

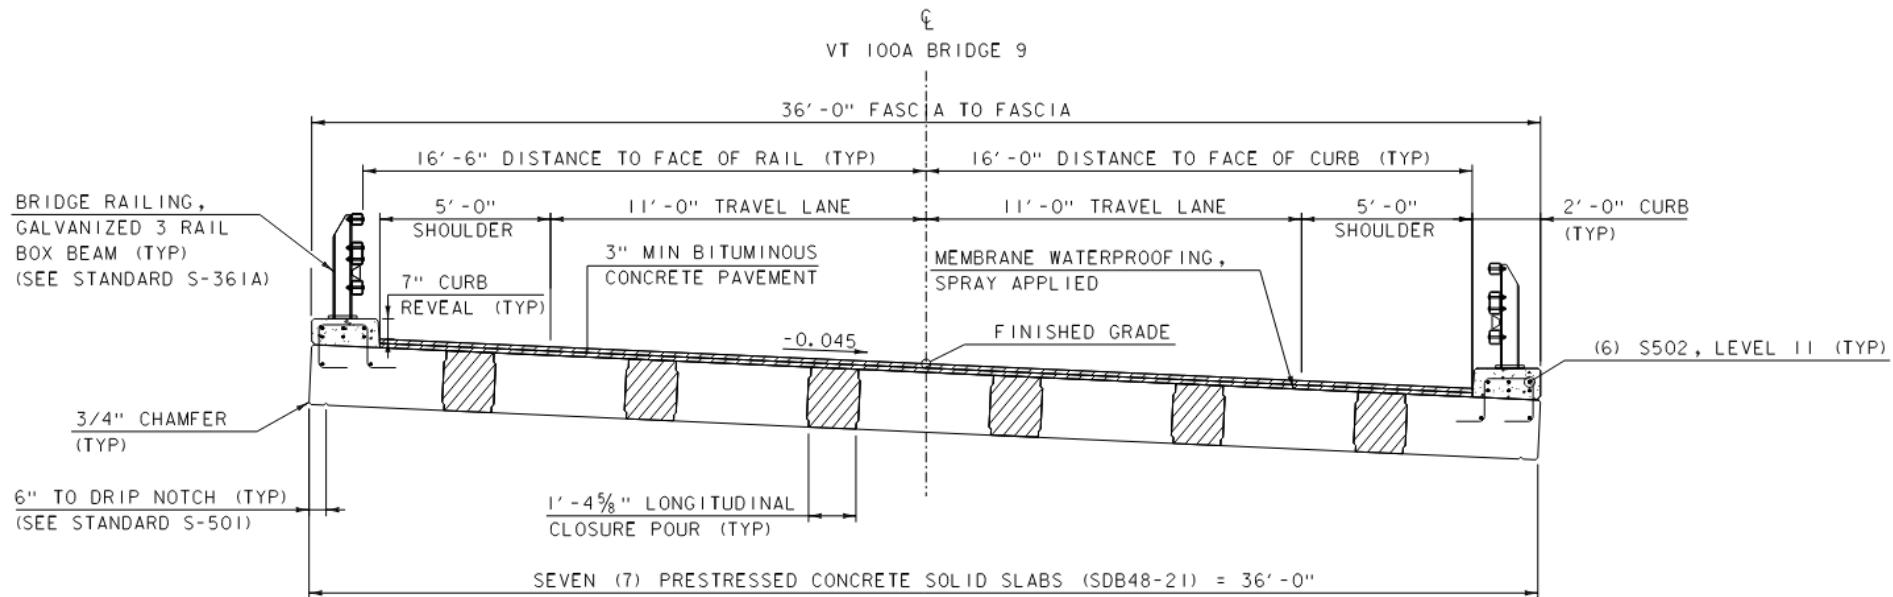
Proposed Bridge Typical Section

- Bridge Replacement
 - 49'-2" span length
 - 36' out-to-out deck width
 - 11' travel lanes
 - 5' shoulders
 - 75-year design life
 - Project construction cost - \$3,459,333.00

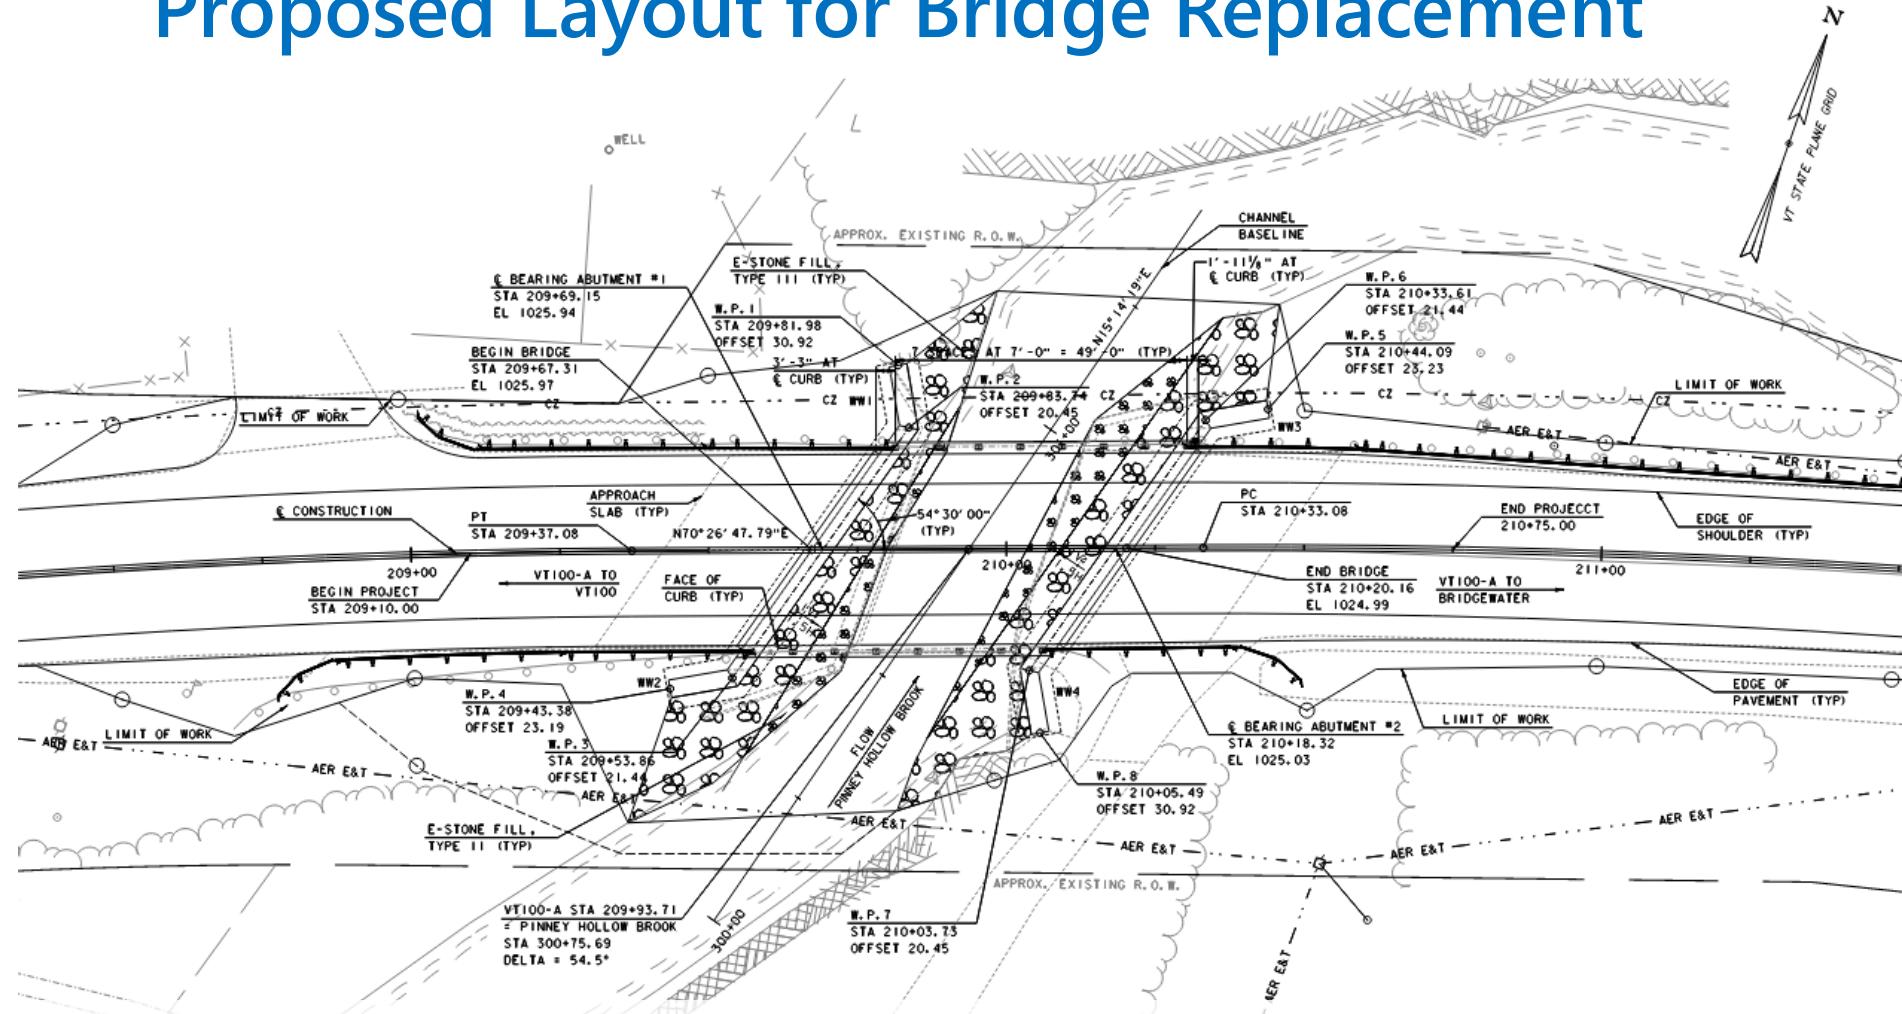
Proposed Layout for Bridge Replacement

- 11'/5' typical
- 75-year design life

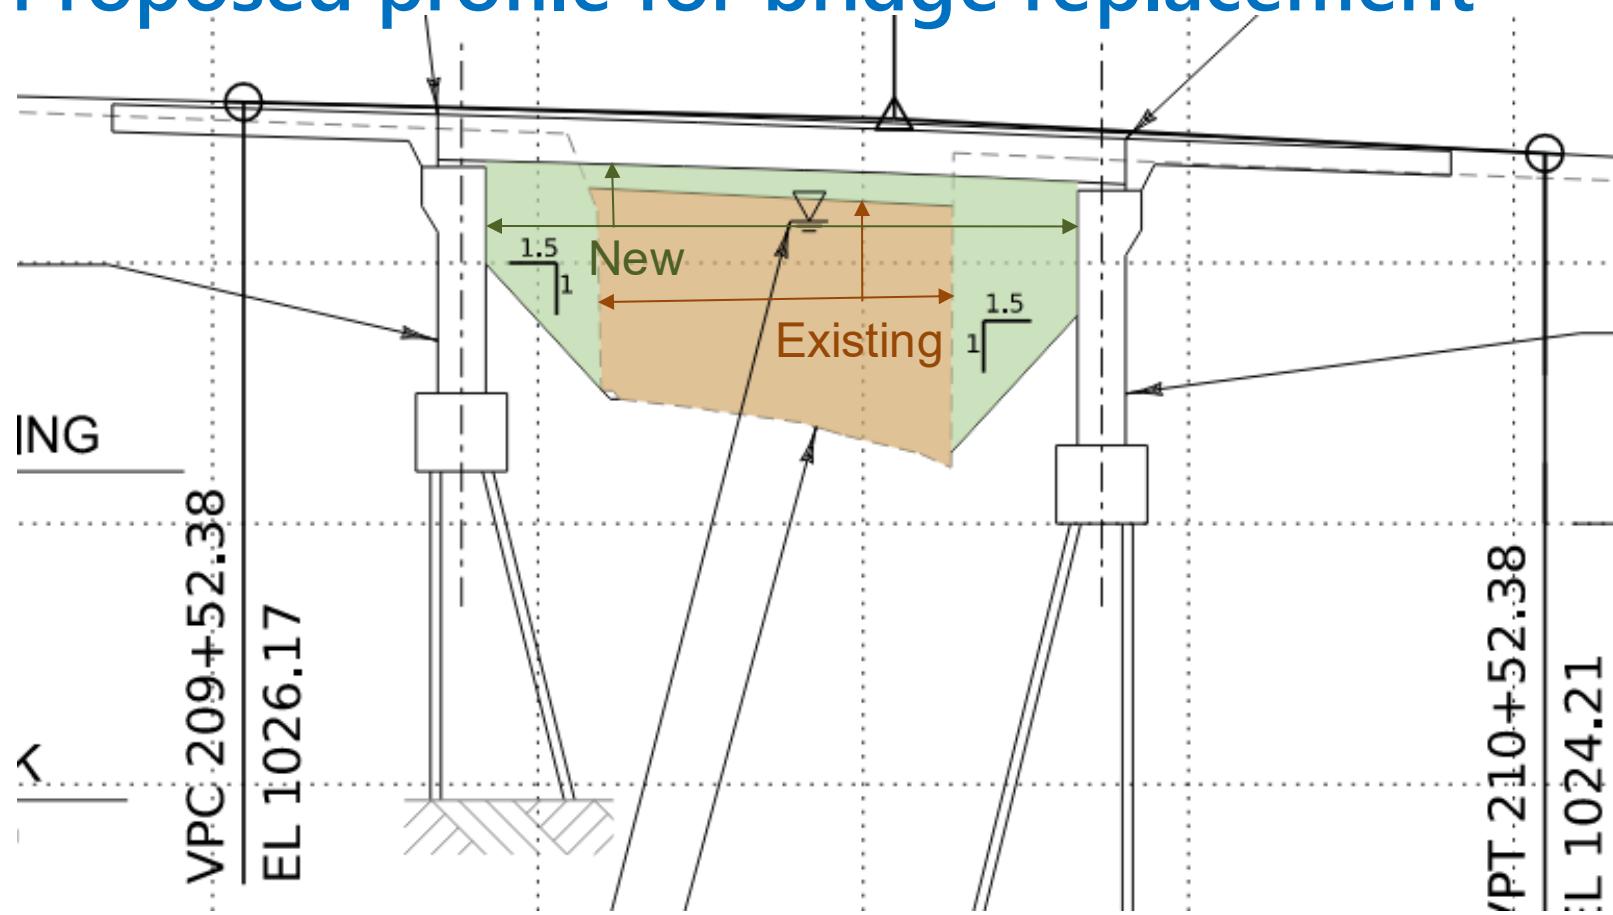
Proposed profile for bridge replacement

- Match existing vertical alignment
- Increase waterway opening

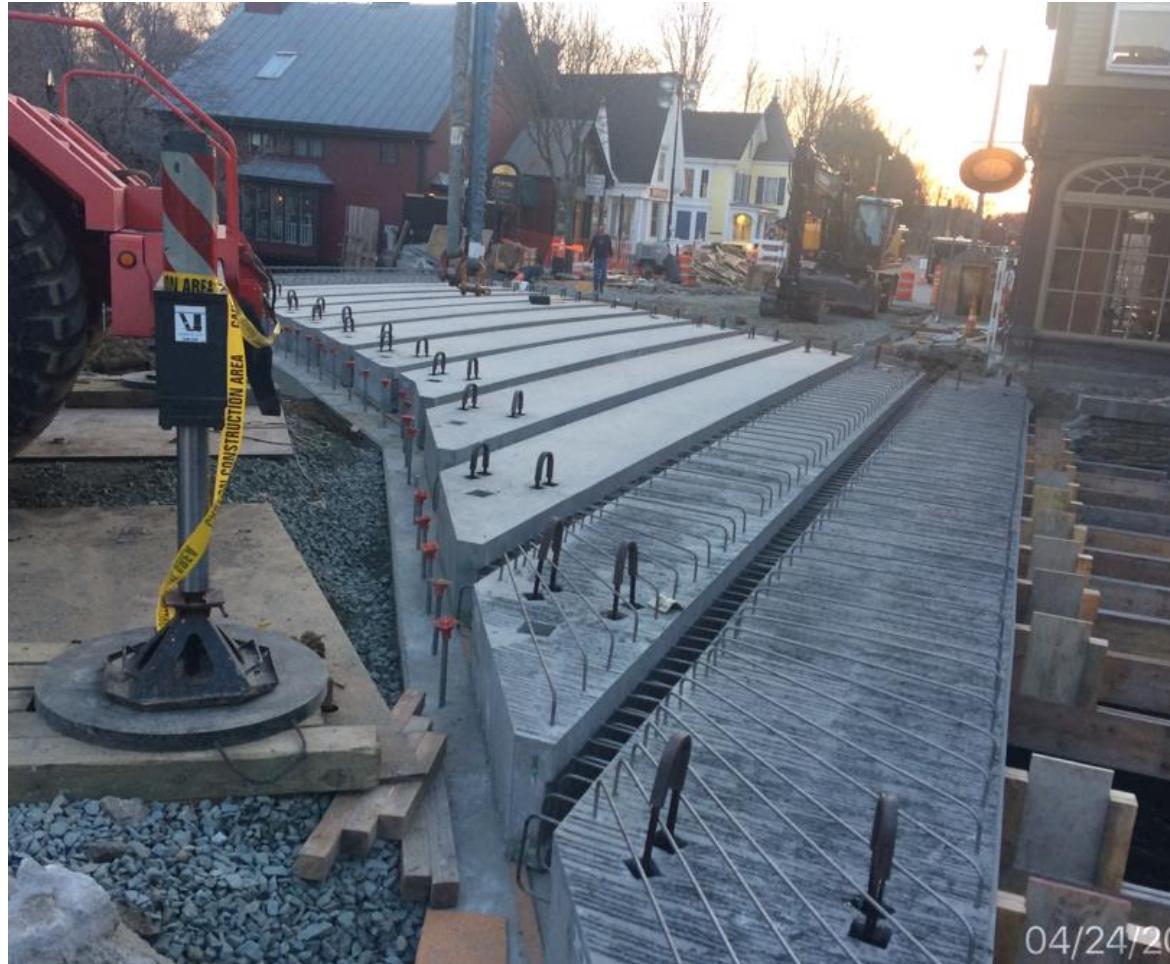
Similar Precast Solid Slabs

- Accelerated elements
 - Abutments – precast
 - Approach slabs – precast
 - Beams – precast
- Conventional components
 - Cast-in-place footings

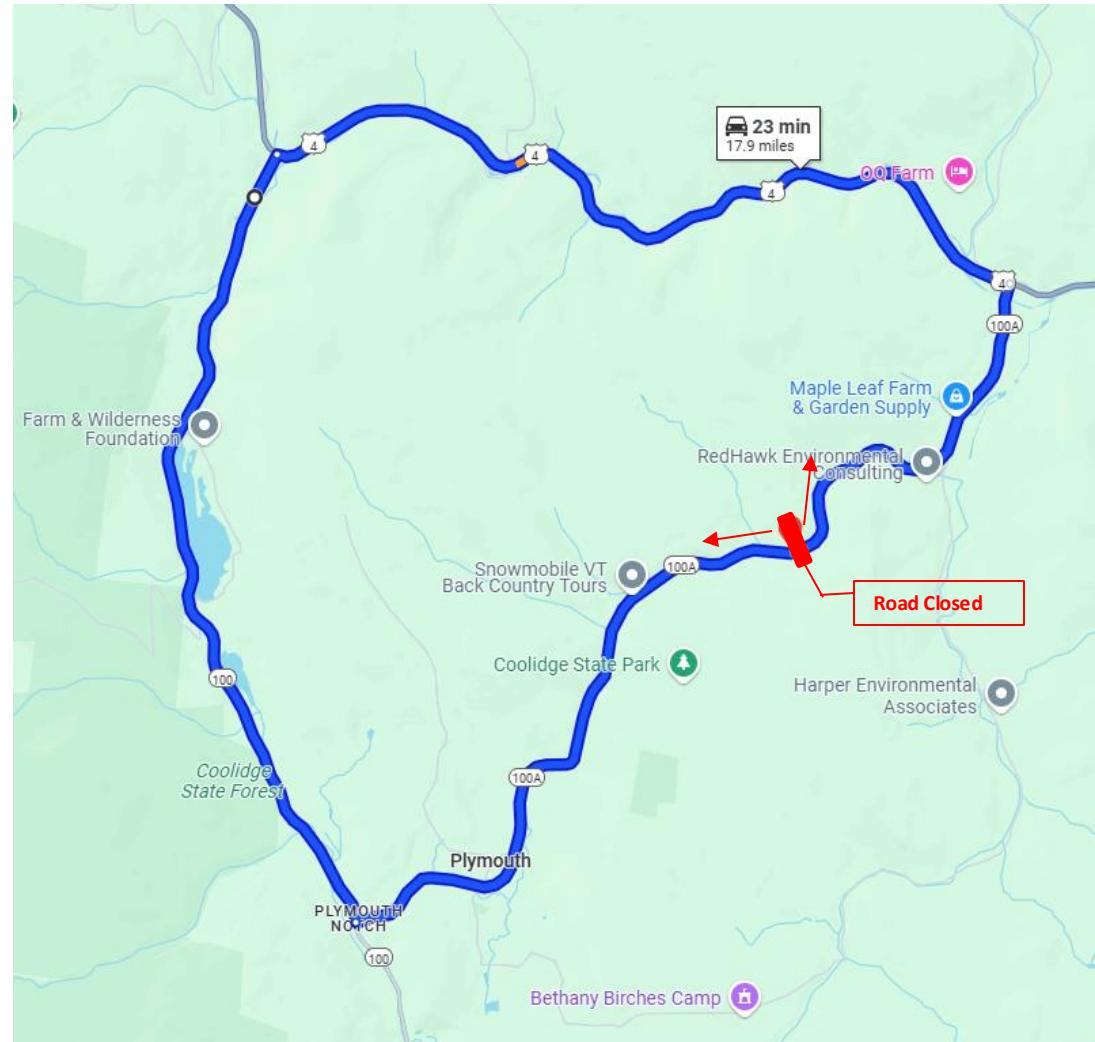
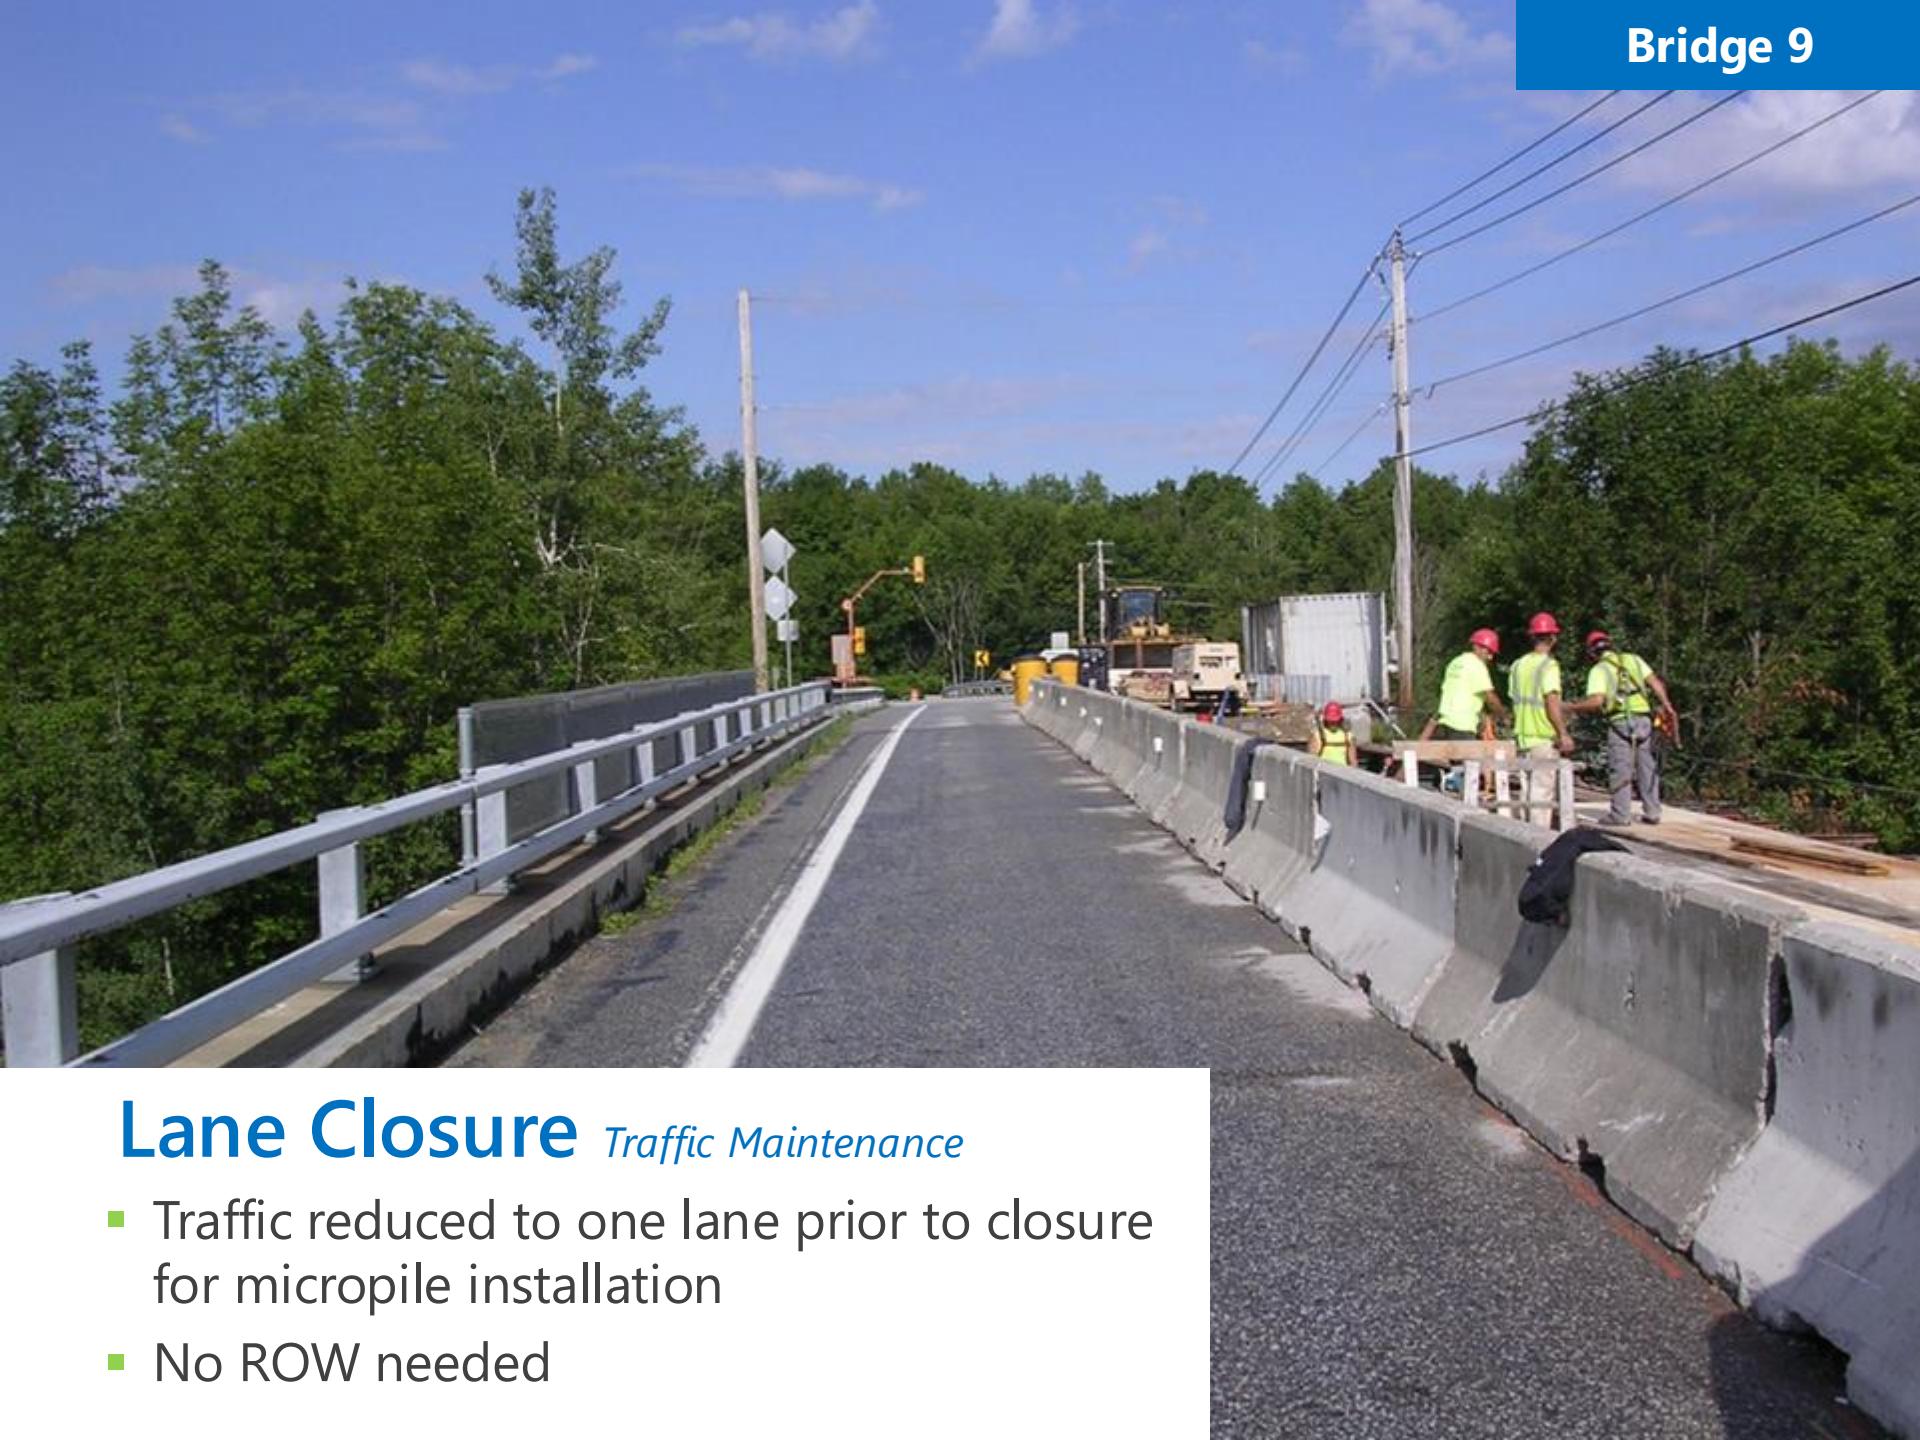
Traffic Control *Regional Detour*

- **Route:** VT Route 100A, to US-4, VT Route 100, back to VT Route 100A.
 - 7.0 miles through route
 - 11.0 miles detour route
 - 17.9 miles end-to-end
 - 4.0 miles added

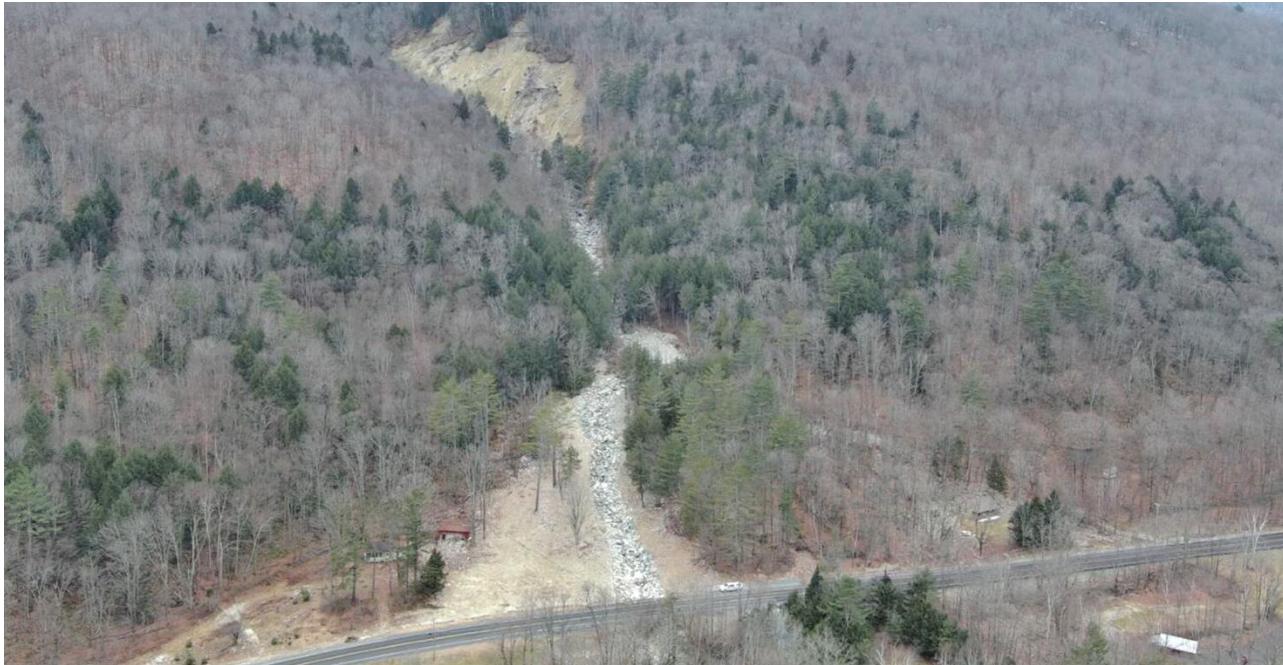
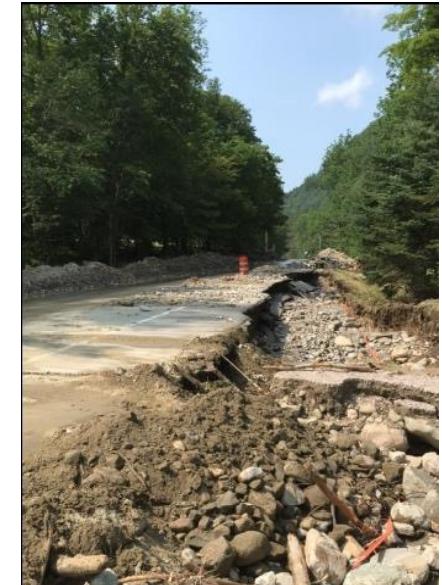
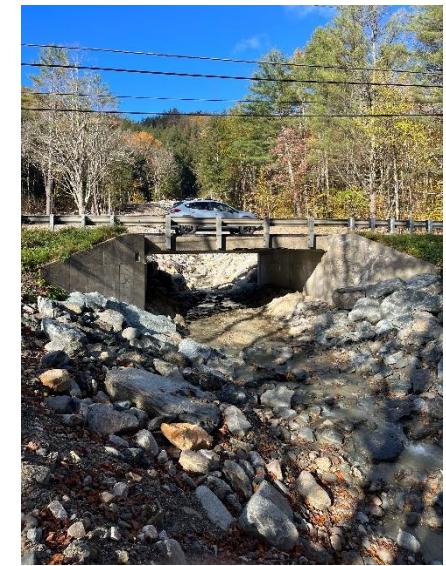
Existing Conditions / Flood Damage (Money Brook)

- Bridge Type – single span, concrete slab
- 24-foot span
- Ownership – State Highway Agency
- Constructed in 1982

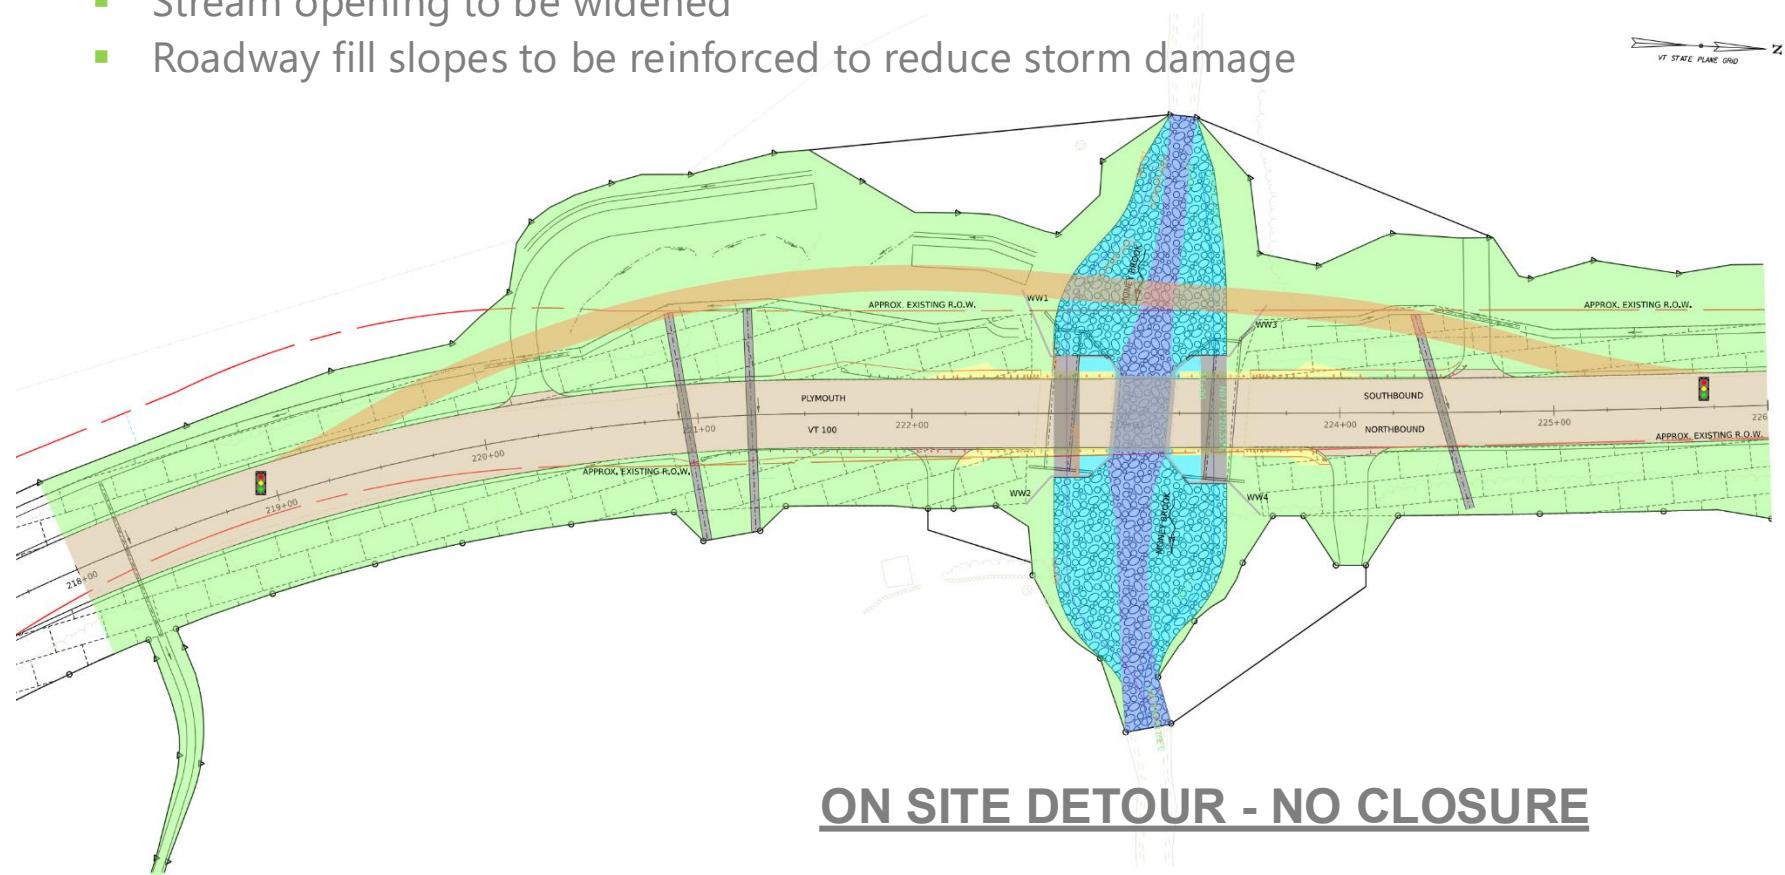
Proposed Layout

- Bridge #108 – Expanding waterway opening with additional culverts
- 11'/5' typical (Lane/Shoulder)
- 24' Span Length (Existing), adding culverts
- Stream opening to be widened
- Roadway fill slopes to be reinforced to reduce storm damage
