Plymouth Bridge Replacement Public Information Meeting

VT Route 100A – Bridge #9 over Pinney Hollow Brook

VT100 Plymouth/Bridgewater Bridge Improvement Projects Public Information Meeting

VT Route 100 – Bridge 108, 112, and 116

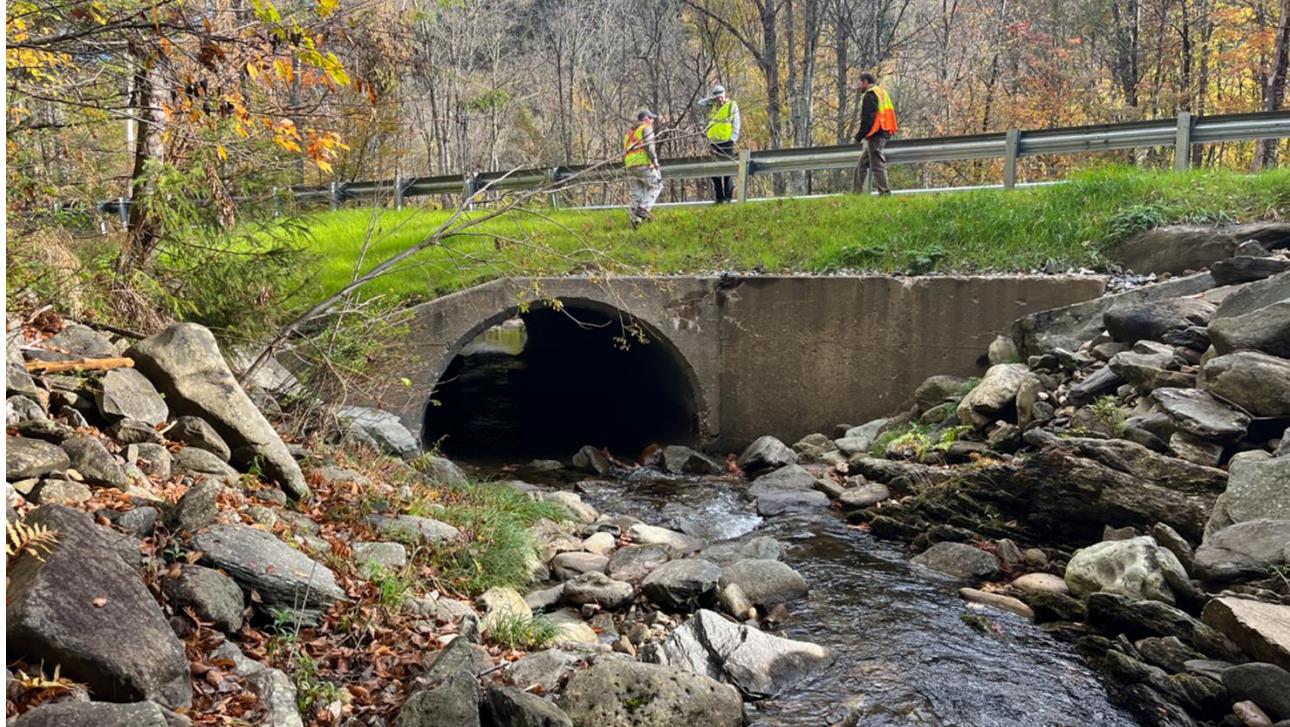
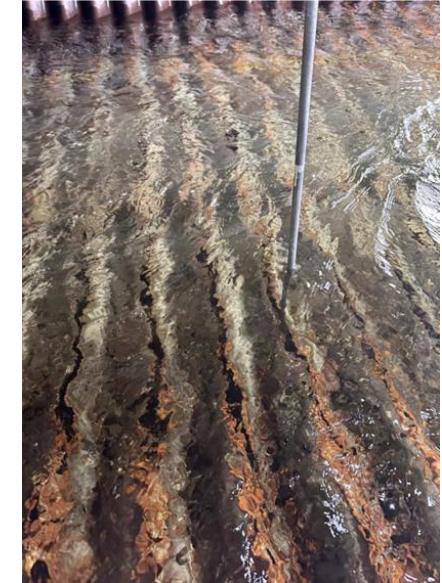
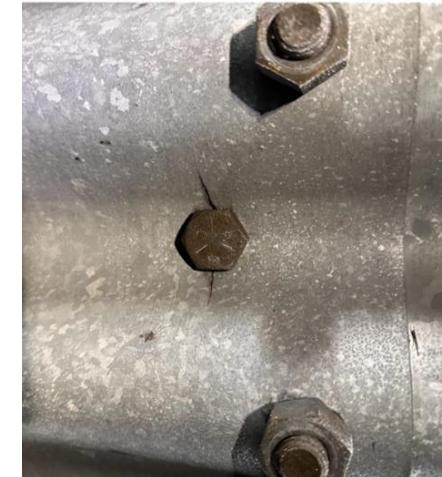
Existing Conditions (Tinker Brook)

- Bridge Type – 11'x7' Galvanized Metal Plate Pipe Arch
- Deteriorated condition / hydraulically undersized
- Ownership – State Highway Agency

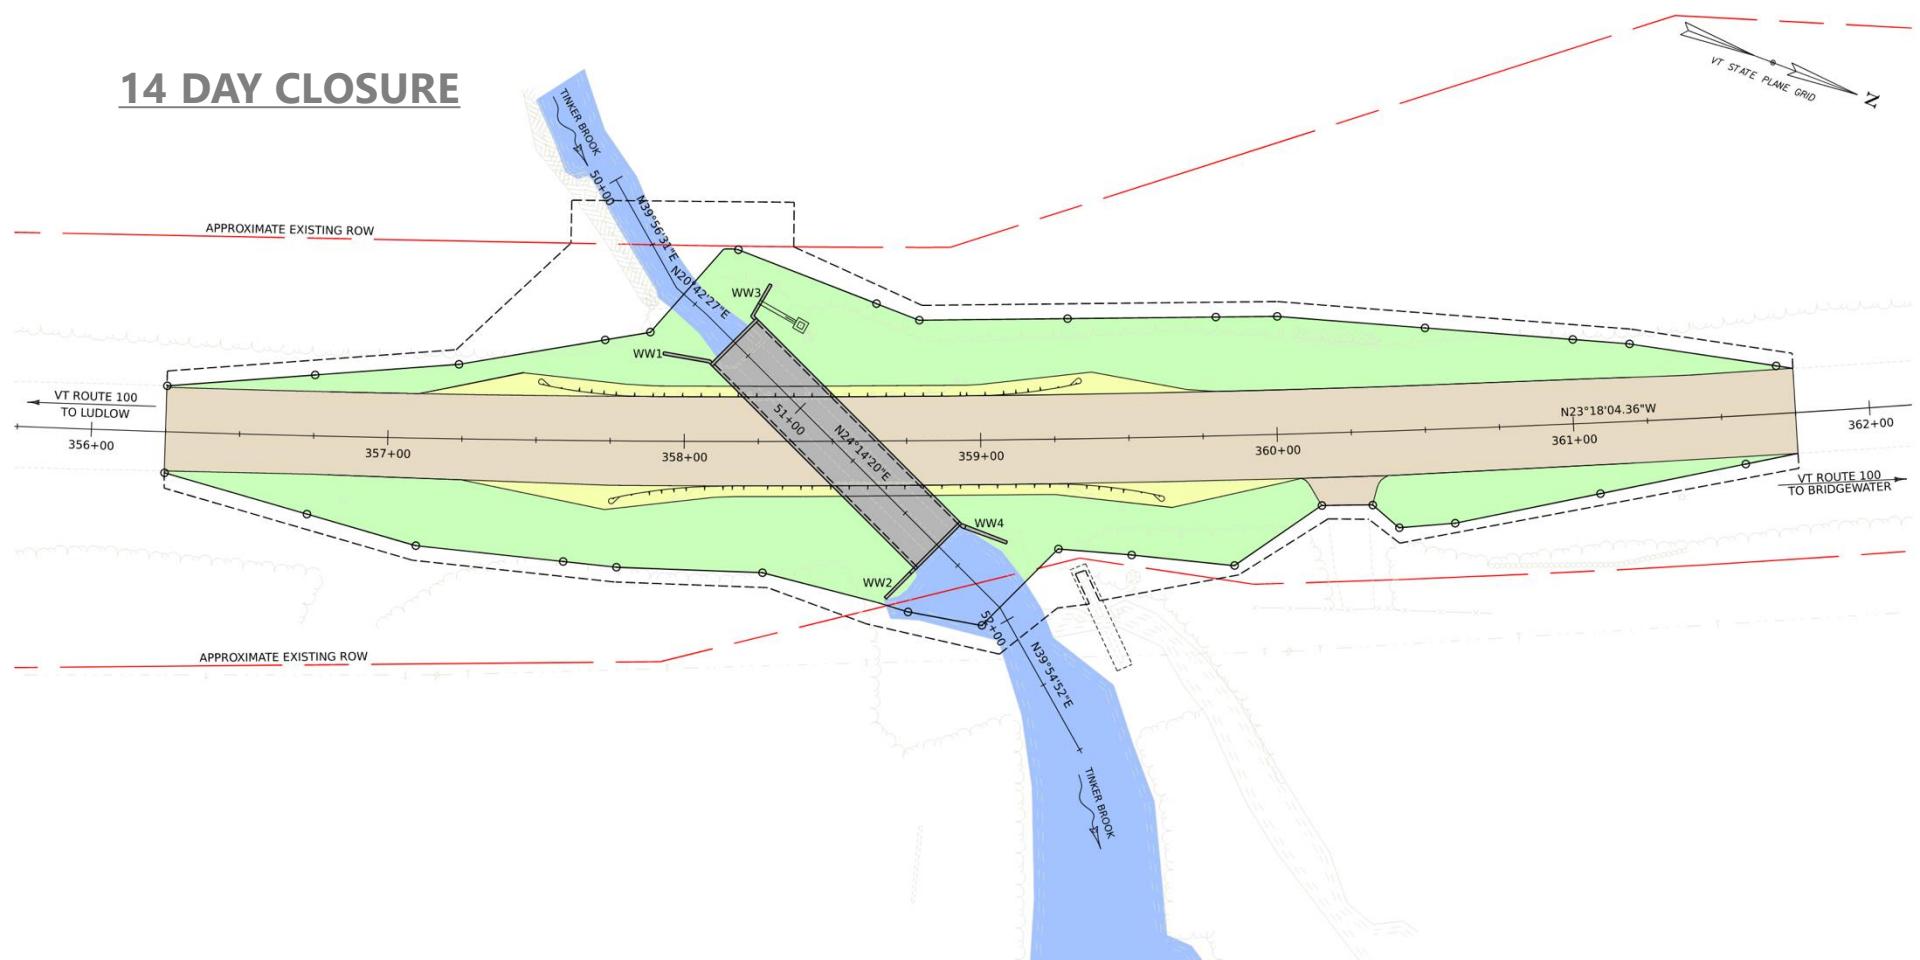
Proposed Layout

Full Bridge Replacement

- 11'/4' Typical (Lane/Shoulder)
- 20' Span Length box culvert with Natural Stream Bottom
- Stream to be re-established in current location

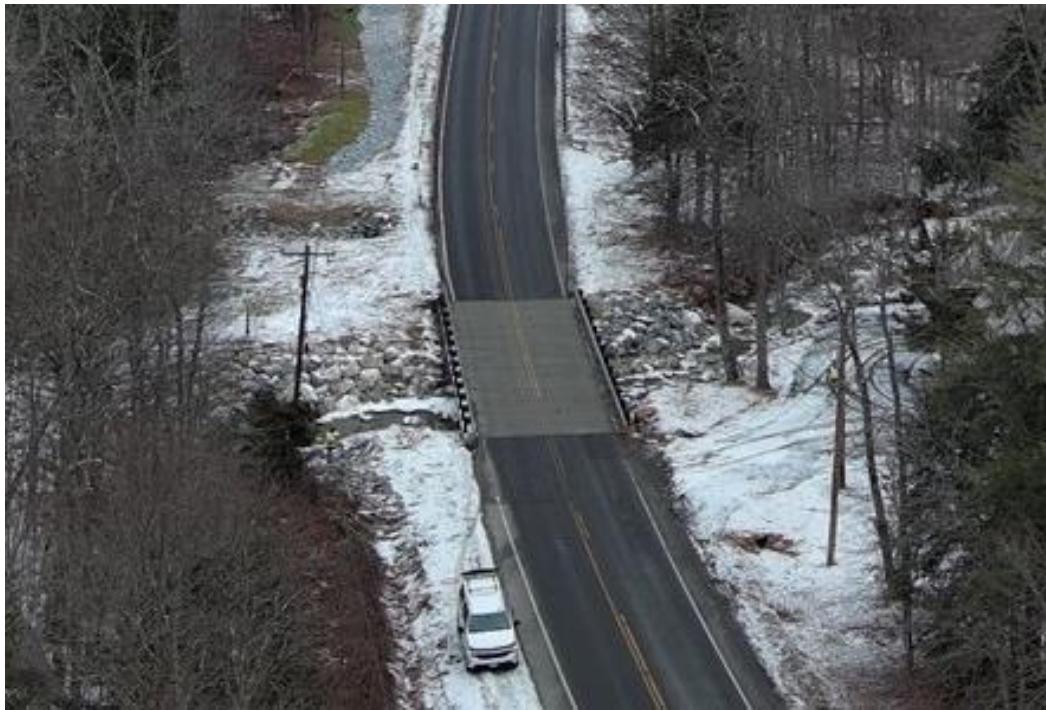
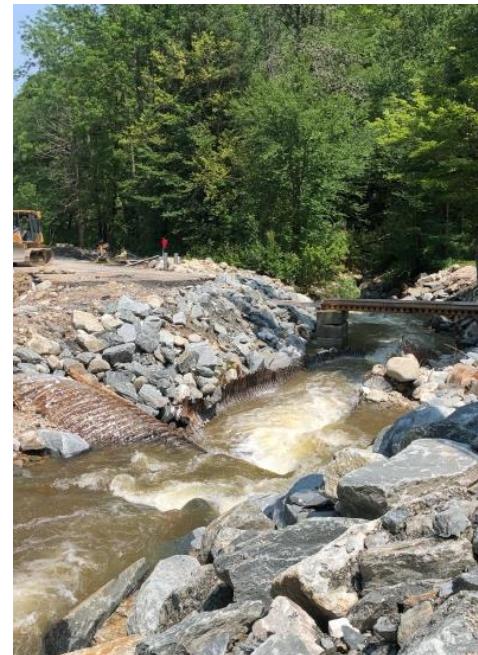
Existing Conditions / Flood Damage (Madden Brook)

- 11'x7' Pipe Arch Bridge Damaged / Removed
- Temporary Bridge Installed After Flood

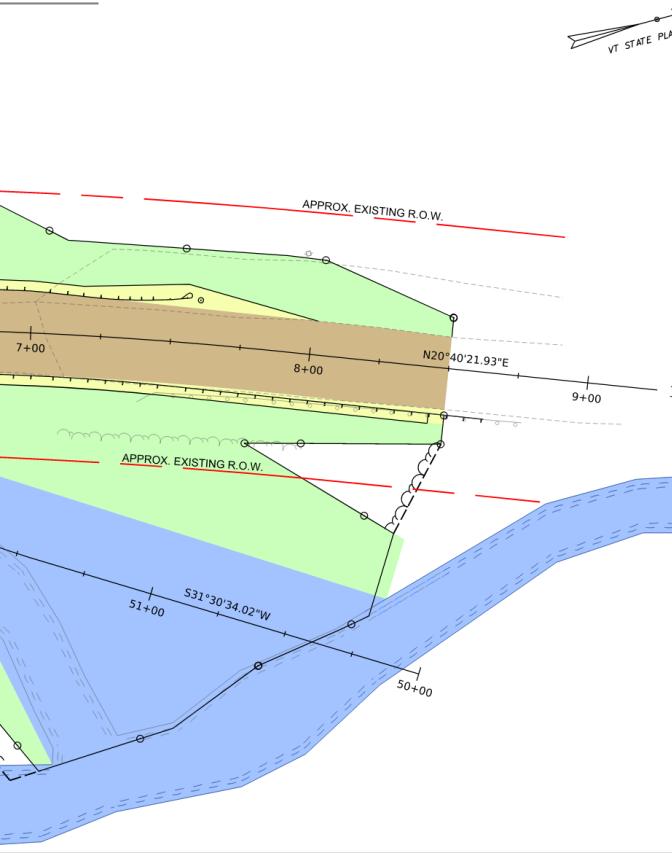
Proposed Layout

Full Bridge Replacement - Bridge #116

- 11'/4' typical
- Replace temporary bridge
- 60' Span Length, 34' Out-to-Out Deck Width
- Stream to be re-aligned and given much more room to carry sediment.
